# Service Bulletin

Bulletin No.: P11286

**Subject:** Hood Flutter, Shake or Vibration at Highway Speeds or over Rough Road Conditions

**Models:** 2015 Cadillac Escalade, Escalade ESV  
2014 Chevrolet Silverado 1500  
2015 Chevrolet Silverado, Suburban, Tahoe  
2014 GMC Sierra 1500  
2015 GMC Sierra, Yukon, Yukon XL

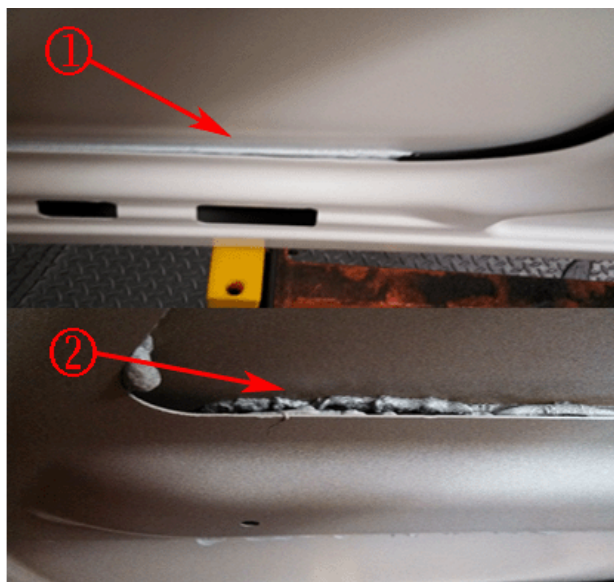
3952015

The inner and outer hood panels may not be sufficiently bonded together at all points. At highway speeds or over rough surfaces, the sheet metal may be able to flutter at some locations.

- (1) Separation
- (2) Gap/Void

Apply panel vibration control material between the inner and outer panels. The procedure below outlines the proper repair instructions. The accompanying illustrations show the most likely areas that may be the source of the fluttering.

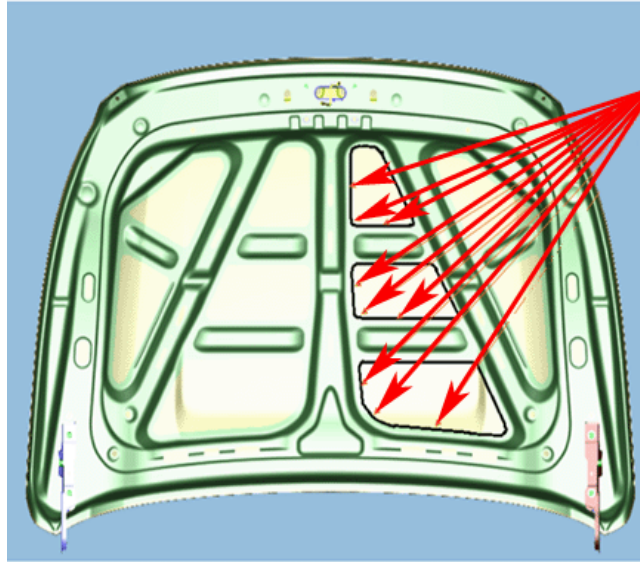
3952018

5. Refer to the picture above (GMC Yukon shown – others similar). In all cases you will be filling the void between the inner and the outer panels to prevent the metal fluttering. The arrows indicate the areas most likely to require additional bonding. Examine the underhood panel for signs of original factory shrinkage or insufficient application, similar to the pictures listed in the Condition/Concern section.
